## #14818: Service Update for Inventory and Customer Vehicles - Body Wire Harness Chafe - Expires with Base Warranty - (Apr 23, 2015)

**Models:** 2015 Chevrolet Colorado  
2015 GMC Canyon

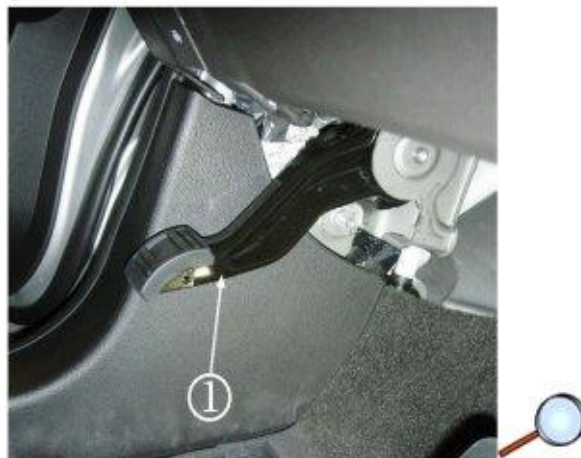
1. Locate the park brake pedal assembly (1). The park brake pedal assembly is located under the instrument panel on the driver side of the vehicle.

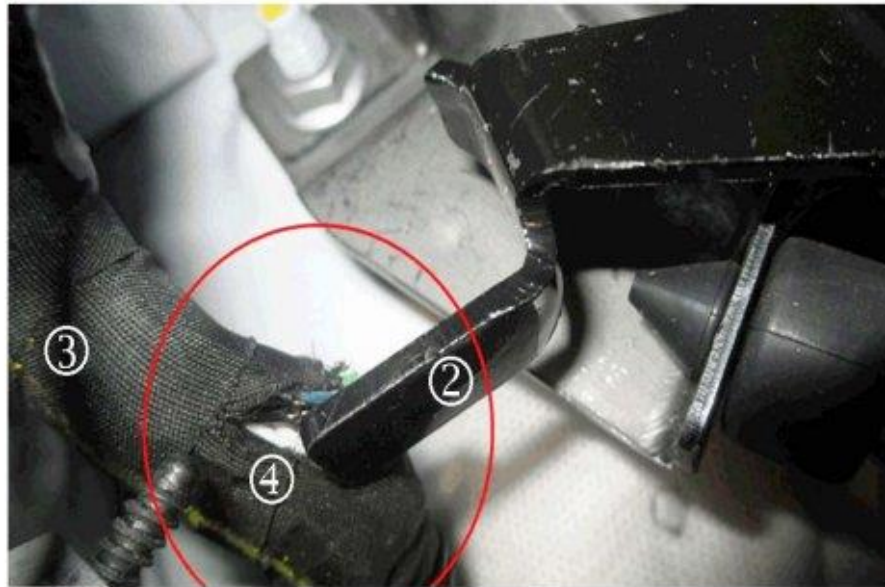
**Note:** Photograph shows a damaged (4) body wire harness. Note the contact between the park brake pedal assembly switch activating tab (2) and the body wire harness (3).

2. Locate the park brake pedal assembly switch activating tab (2) and body wire harness (3).
3. Using a flash light determine if the body wire harness has been damaged (4) by park brake pedal switch activating tab.

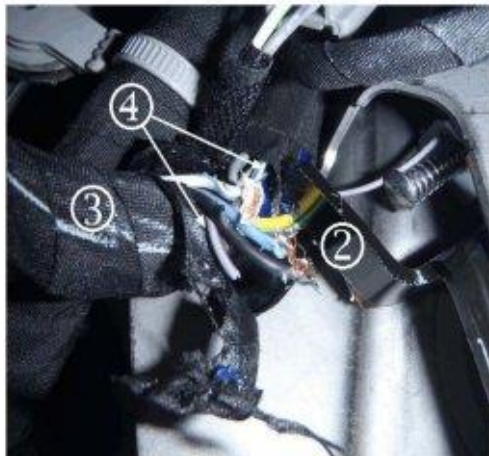
- If the body wire harness (3) is chafed and damaged (4) by the park brake pedal assembly switch activating tab (2), proceed to step 4.
  - If the body wire harness is NOT chafed and damaged by the park brake pedal assembly switch activating tab, proceed to step 8.
4. Remove tape from body wire harness to gain access to the damaged portion of the body wire harness.

5. Repair damaged wires using wire repair information in SI. Refer to *Splicing Copper Wire Using Splice Sleeves* in SI for splicing instructions.
6. Wrap electrical tape around the repaired portion of the body wire harness.
7. Wrap woven polyester electrical tape (PET) or equivalent anti-abrasion tape around the repaired portion of the body wire harness.

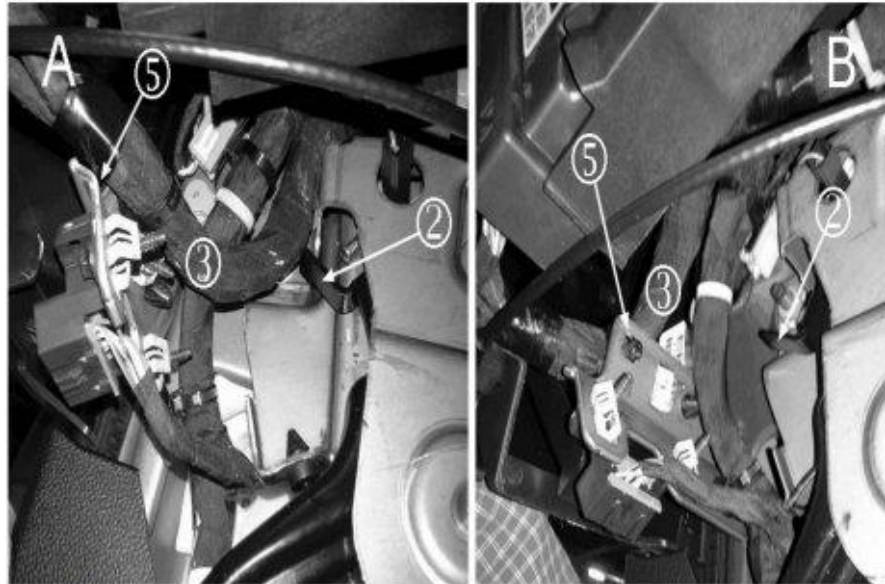
**Note:** (A) An incorrectly routed body wire harness. The body wire harness contacts the park brake pedal switch activating tab (2). The body wire harness is mounted on the front side of the bracket.

(B) A correctly routed body wire harness. The body wire harness does NOT contact the park brake pedal switch activating tab (2). The body wire harness is mounted on the backside of the bracket.

8. Determine if the body wire harness is routed correctly. A correctly routed body wire harness will NOT contact the park brake pedal switch activating tab. In addition, the body wire harness clip on a correctly routed body wire harness is installed on the backside of the mounting bracket.

- If the body wire harness is NOT routed correctly and it contacts the park brake pedal assembly switch activating tab, proceed to step 9.
9. Detach the body wire harness from the front side of the bracket and install the body wire harness clip to the backside of the bracket.

10. Ensure the body wire harness is routed correctly and does NOT contact the park brake pedal assembly switch activating tab.
