#16-NA-079: Audio System Speaker Rattle, Buzz Noise, Poor Sound When Playing Radio or Other Music Source - (Jul 15, 2016)

Brand:	Model:	Model Year:		VIN:		Engine:	Transmission:
		from	to	from	to		
Chevrolet	Colorado	2015	2016			All	All
GMC	Canyon	2015	2016			All	All

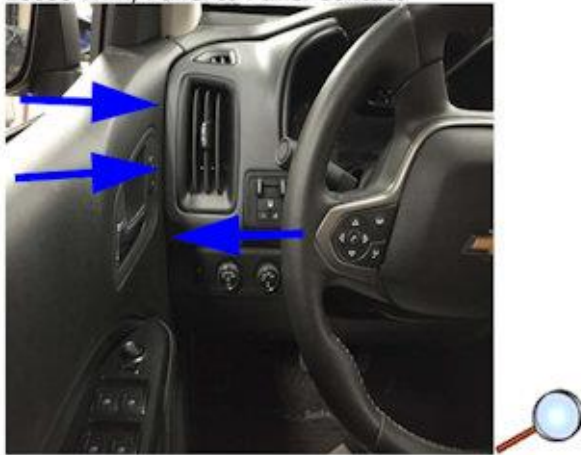
Loose Trim, Panel to Panel Contact

An interface may cause a rattle or buzz (for example, between a door and instrument panel).

- To better identify the location, open the door and determine if the buzz or rattle follows the door. This may be caused by loose door trim, water deflector contact with the trim, or wire harness conduit coming into contact with the inner door sheet metal. Refer to **Door Trim/Water Deflector/Harness Rattle** below.
- Determine if a rattle is heard between the instrument panel and door. This may be caused by contact between the instrument panel and the door trim when the door is closed. If the noise goes away when the door is opened, inspect the trim panel on the door to ensure it is in the correct position. Also, inspect the snap-on trim panels on the instrument panel ends to ensure they are fully engaged into the instrument panel.

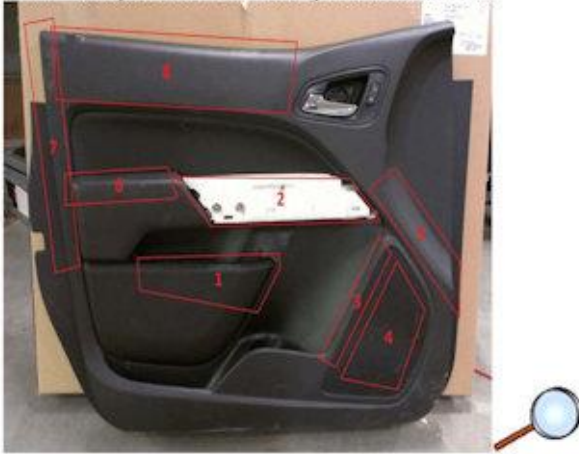
Door Trim/Water Deflector/Harness Rattle

If the rattle is heard within the door trim, check the locations shown above by depressing the trim with your hand. If the sound changes or the rattle/buzz decreases when pressure is applied, follow the steps below.
