#17-NA-065: Hood Flutter, Shake or Vibration at Highway Speeds or over Rough Road Conditions - (Mar 10, 2017)

Subject: Hood Flutter, Shake or Vibration at Highway Speeds or over Rough Road Conditions

Brand:	Model:	Model Year:		VIN:		Engine:	Transmission:
		from	to	from	to		
Buick	Envision	2016	2017			All	All

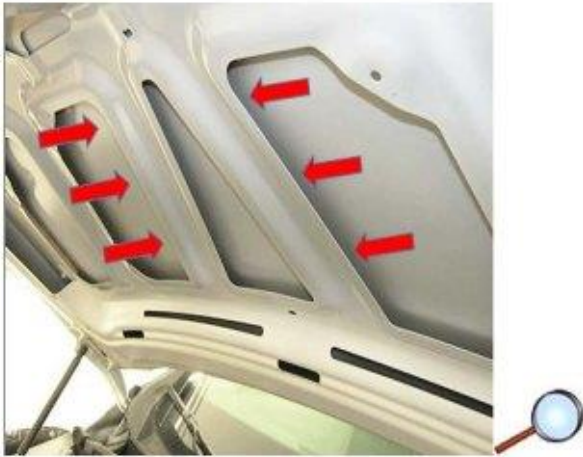
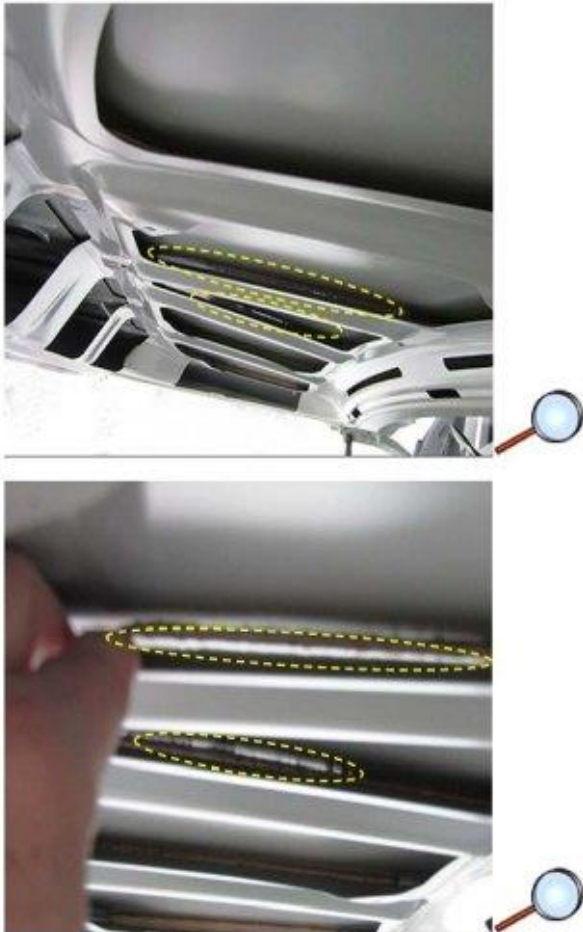
<p>Note: As shown in the graphic examples above, the panels may show evidence of separation and/or a gap or void in the original adhesive material.</p> <p>The cause of the condition may be that the inner and outer hood panels may not be sufficiently bonded together at all points. At highway speeds or over rough surfaces, the outer sheet metal may show signs of a flutter at some locations.</p>
Correction	To prevent the metal from fluttering, apply panel vibration control material between the inner and outer hood panels, following the Service Procedure below.

5. Using a non-expanding two-part panel control vibration material, such as SEM 39977*, 3M™ 04274*, or equivalent, fill the voids between the inner and outer hood panels. Keep the tip of the applicator right up against the panel in order to allow the material to flow in between the panels. Follow the manufacturer's instructions for proper application.

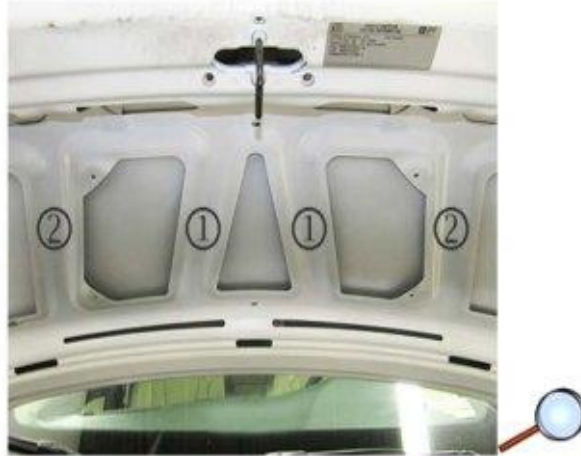
Note: The condition is most commonly found at the two center-most inner panels (1), however in some cases the next outboard inner panels (2) may also be affected.

4. The graphic above shows the areas most likely to require bonding. Examine the underhood panel for signs of original factory shrinkage or insufficient application, similar to the pictures listed in the Cause section.
