2019 Chevy Truck Traverse AWD V6-3.6L

#18-NA-293: Drawn Out Creak Noise Heard from Upper Door and/or Window Area - (Oct 25, 2018)

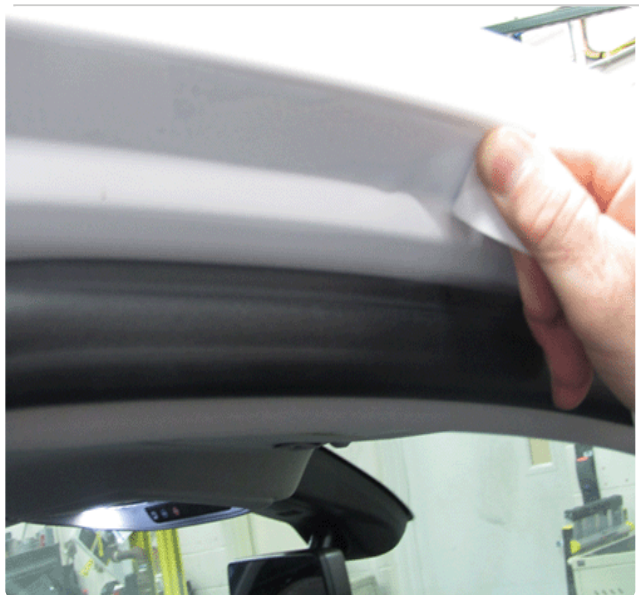
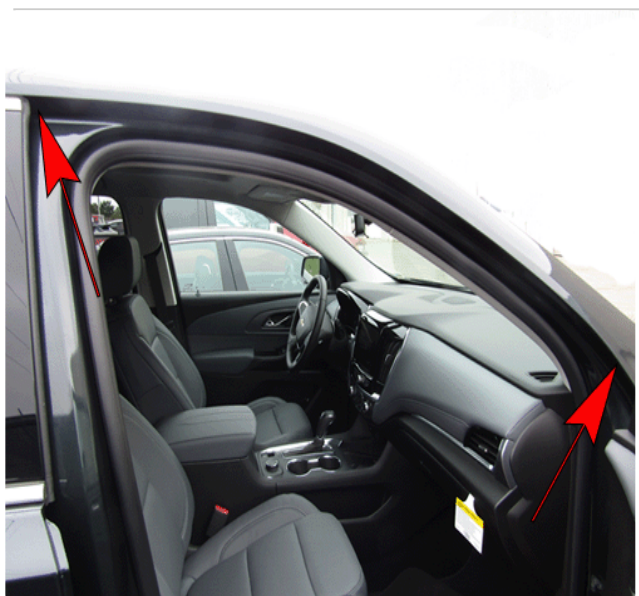
Involved Region or Country	North America and NA Export vehicles
Condition	Some customers may comment on a low frequency, drawn out creak noise in the upper door and/or header area on multiple doors. This noise is usually initiated by inputs such as driving over cracks at low speeds, turning, or accelerating.
Cause	This condition may be caused by the interface between the doors' weather seal and the body roof rail.
Correction	Apply strips of KT13512 Anti-Squeak Film Tape or equivalent UHMW Polyethylene anti-squeak tape to both sides of the vehicles roof rail following the procedure below.

3. Peel the backing and apply the strips to the front roof rail, as shown in the illustrations above.

Note: The anti-squeak tape needs to be applied as close to outer edge of the door ring as possible but insuring that the tape **DOES NOT** protrude onto the outer show surface of the door ring.
