NUMBER: 23-029-15

Water In Right Front Floor Footwell

This bulletin involves correcting a sealant void between the cowl plenum lower panel and dash crossmember.

2015 (KL) Jeep Cherokee

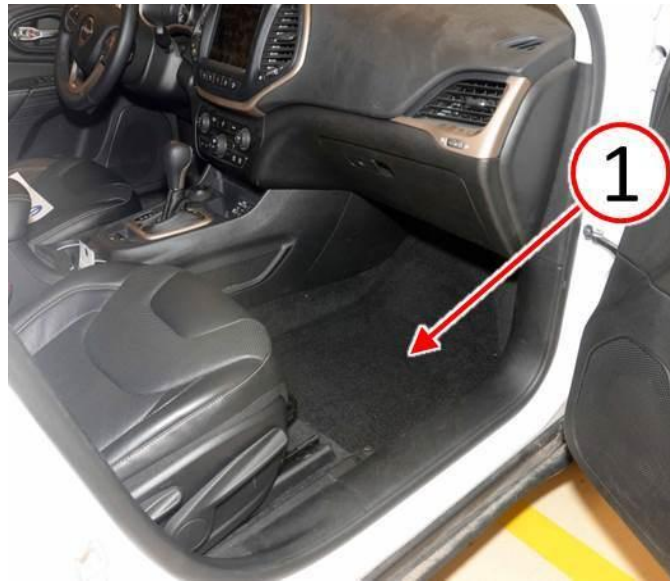
The customer may describe damp or wet carpet in the right front footwell ([Fig. 1](#)). This condition may be due to a sealant void between the cowl plenum lower panel and dash crossmember allowing water to enter the vehicle interior.

Fig. 1 Water In Right Side Front Footwell

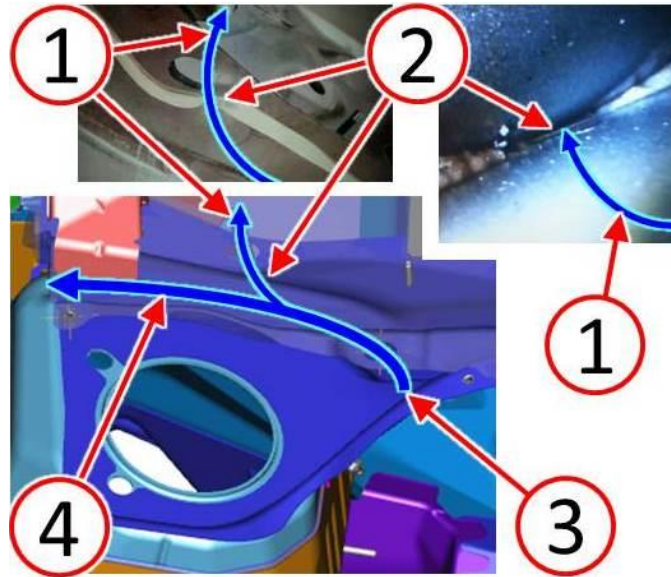
NOTE: Images in (Fig. 9) show the proper water path (4) across the dash crossmember water management trough and also shows the location of the sealant void area (2) between the cowl plenum lower panel and dash crossmember which allows water (1) to enter the vehicle interior right front footwell.

Fig. 9 Sealant Void And Water Path

- 1 - Water Leak Path To Vehicle Interior
 - 2 - Seam Sealant Void Location
 - 3 - Opening Into Water Management Trough
 - 4 - Proper Water Path Along Water Management Trough
-

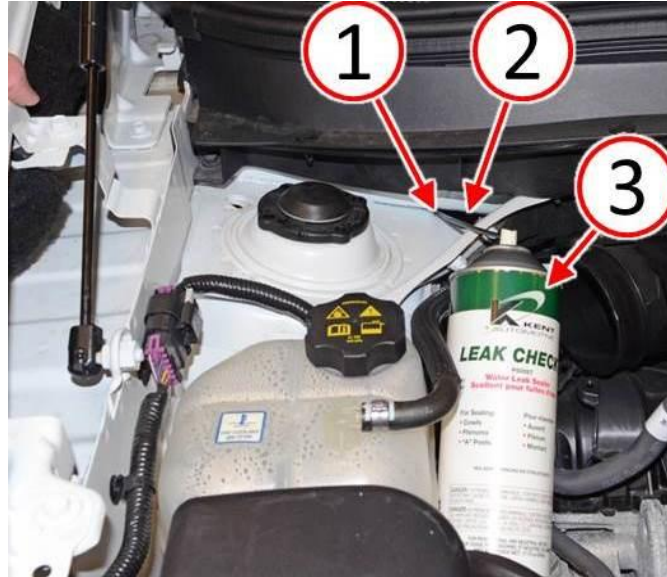
Fig. 10 Apply Seam Sealant

10. Direct the Kent® spray leak check sealer extension tube (1) into the water entrance opening (2), between the cowl plenum lower panel and dash crossmember. Fully insert the extension tube (1) until it reaches the rearward seam in the approximate location of the sealant void area (Fig. 10).
11. Spray the Kent® leak check sealer (3) continuously along the rearward seam for the full range allowed in the opening between the cowl plenum lower panel and dash crossmember (Fig. 10).
12. Allow the Kent® spray leak check sealer to dry per the manufacturer's directions; approximately 15 minutes. Then repeat the application process for the second coat of sealant.

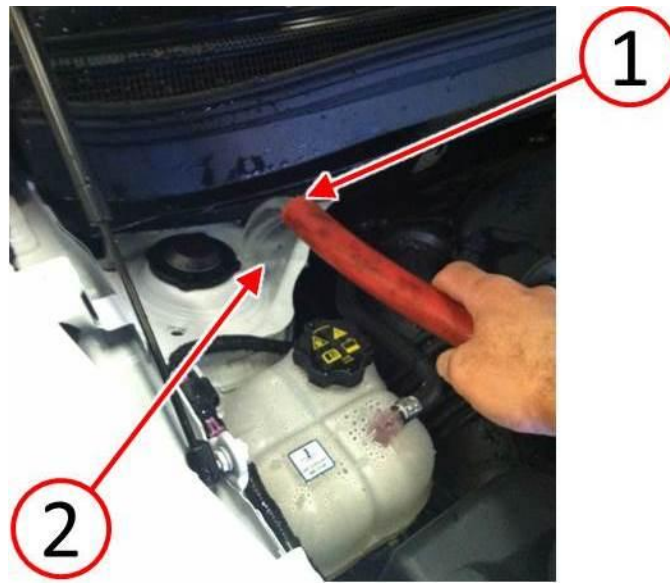
Fig. 11 Water Test

13. After the sealant has been allowed to fully dry, flow water (1) into the opening (2) between the cowl plenum lower panel and dash crossmember for one full minute (Fig. 11). While water is flowing, inspect for any water leaks as described in [Step #14](#).

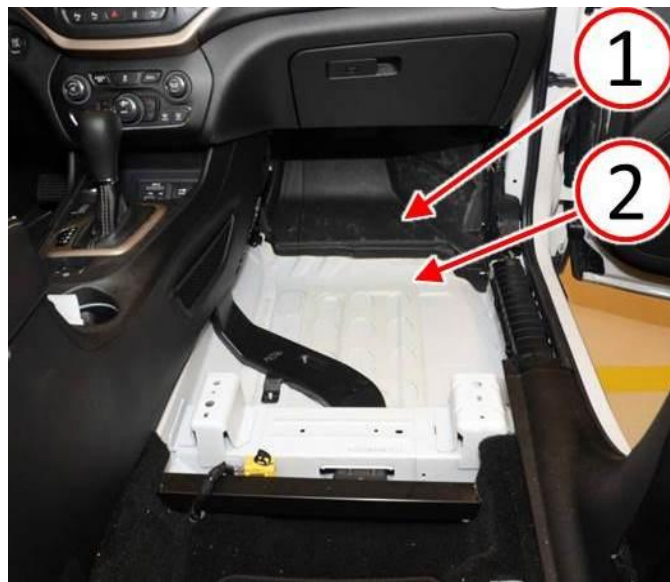
Fig. 12 Inspect For Water Leak

14. Inspect for any trace of water coming from under the insulating material (1) and appearing in the right front footwell (2) (Fig. 12). If no water is found entering the vehicle interior during the water test then the sealant process is complete.
