#PI1005C: Exterior Roof Panel Sag/Depression - (May 26, 2017)

Subject: Exterior Roof Panel Sag/Depression

Models: 2013-2017 Chevrolet Express Extended Vans (Passenger and Cargo)
2013-2017 GMC Savana Extended Vans (Passenger and Cargo)

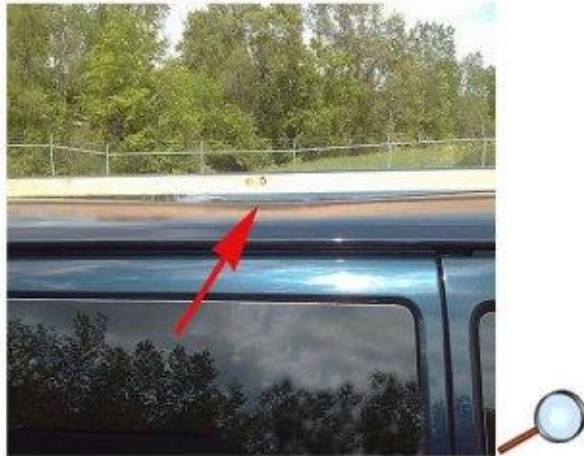
Some customers may comment that a sag/depression area appears on the roof of the vehicle at times and then goes away. This condition is most prevalent on dark colored vehicles. The affected area is 3 to 7 feet (0.9-2.1 m) from the rear edge of the roof with the deepest depression at 5 feet (1.5 m) from rear edge. The sag appears when the van is sitting outside in the sun and it will go away when van roof surface cools down but will re-appear when parked back in the sun. This sag is most prevalent on the passenger side of the vehicle. In some rare cases it may also appear on the driver side.

This condition is caused by an insufficient amount of (anti-flutter) sealer between the third and fourth roof bows and the outer panel. As the roof panel expands in the sunlight, the sealer does not expand as intended, causing the low areas to appear.

Use the following steps to remove the sealer (anti-flutter) in the affected area and install shim material.
